## DAMAGE INSPECTION ON PIER OF SG. PERAK RESERVOIR BRIDGE USING ACCELEROMETER AND GNSS

Sg. Perak Reservoir Bridge where it is commonly known to be heavily utilized by heavy vehicles on daily basis. Therefore, the practices of inspection and maintenance of this bridge are essential tasks in prolonging its lifespan especially as it is utilized heavily with heavy vehicles. The act of inspecting damage that occurred at a pier is done through the use of technical equipment as an additional method invalidating visual inspection obtained through vibration reading, and validating in inspection reading analysis as additional information to confirm for any structural damages. The use of using Global Navigation Satellite System (GNSS) can be employed for continuous monitoring and the use of accelerometers, which are components of the ambient vibration method, served to be an integral part of the information obtained on the changes in the dynamic structural features detected. The vibration measurement can display natural frequencies that depended on the weight, material, pressure, and tension as well as the geometry of the object. This data obtained can therefore be used to furnish additiona

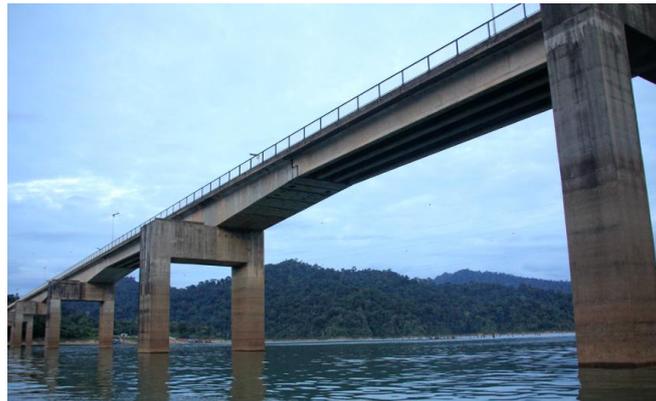
**Figure 1: The Structure Of Sungai Perak Reservoir Bridge**

Sg. Perak Reservoir Bridge was built in 1978, as illustrated in Figure 1. It spans across the Banding Lake, between Gerik and the island of Banding, accommodating two vehicle lanes and a non-pedestrian walkway.

It is an asymmetrical suspension bridge having a total length of 880.52 meters over fourteen spans where the maximum span is 91.46 meters, and the width of the carriageway is 8.48 meters. It has a non-Reinforced Concrete (RC) tower.

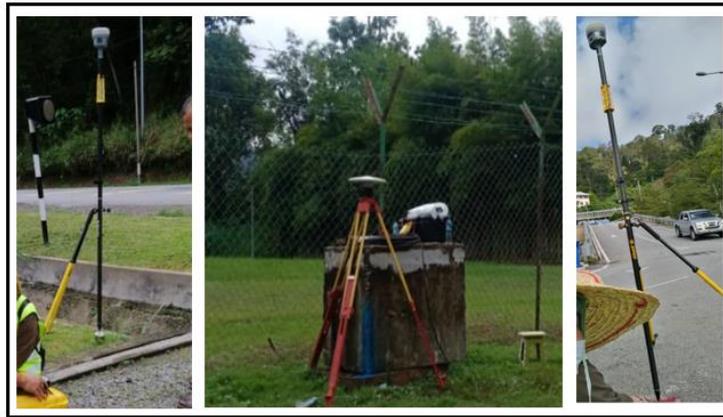
**Figure 2: Base 1, Base 2 And Base 3 Which As The CORS Malaysia Reference Station.**

Table 1 shows the locations of three (3) reference stations that have been set up namely BASE 1, BASE 2, BASE 3 and VRS. This station is referred to as a Virtual Reference Station (VRS). VRS is a reference station generated through JUPEM SpiderWeb in Malaysia. This reference station is powered by MyRTK Network Malaysia station which is operated 24 hours daily. Only three (3) stations were used for this purpose of observation and complete information regarding this station can see in Figure 2 below.

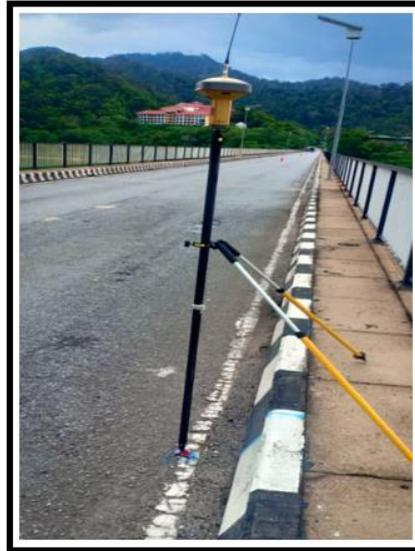
**Figure 3: Position Of Observation Point At The Sg. Perak Reservoir Bridge.**

The natural frequencies of individual elements of the bridge were unknown in advance and likely to have higher vibration modes (Gaglione et al., 2018). Therefore, a sampling rate of 20,000 Hz was set at the Accelerometer. The data is locally stored at the device and downloaded in bulk at the end of the data acquisition period. The locations were chosen by trial and error aiming to find structural members showing high amplitude vibrations in the time domain of the frequency domain. The best locations seemed to be at the top of the pier members on the bridge slab, as shown in Figure 3.

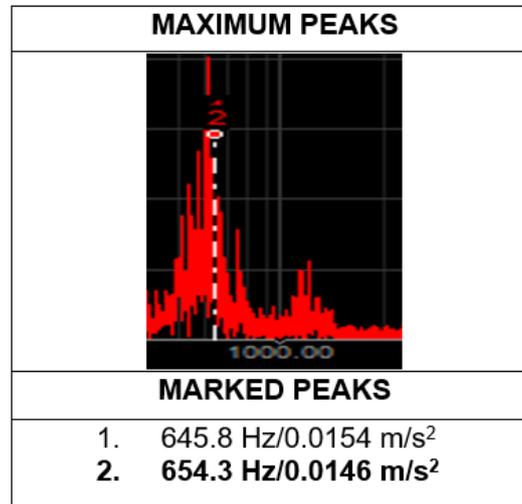
**Figure 4: Output Of The Signal Of KB01 Observation Point.**

By referring to Figure 4, the Reading obtained for the KB01 observation point, showed the values are at their maximum high peak when the observations were recorded. This data is directly displayed by the processing software and at that time, the list of numbers indicates the readings at its maximum. The reading on marked peaks of KB01 refers to the highest signal reading with a value of 0.0146 m/s<sup>2</sup>.

The value choice for marked peaks vibration is obtained by observing the highest signal that is marked by a number displayed by the DEWESoft software interface.

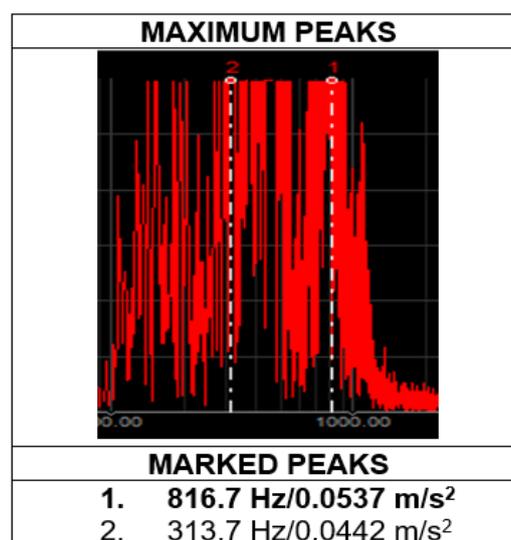
**Figure 5: Output Of The Signal Of KB11 Observation Point.**

For Figure 5 and Figure 6, each of them showed readings at the level of more than 30 mm/s, whereas the graphic with its signal displayed that showed its peak mark is chosen. All these 3 observation points were placed at the same point at the point position for the GNSS observation.
